15 Struck by skids of falling electrical motors – Inspection #1164151

A **66 year old male** employee of a contractor was fatally injured when he was struck by a double stacked skid of residential HVAC motors. On the day of the incident, the victim was walking down a designated aisle way in the host employer's warehouse, to exit the building, when a double stacked skid of 140 air conditioner motors, weighing approximately 1,540 lbs., fell over striking the victim and crushing him. During the investigation at the host employer's warehouse, items were found to be over stocked, materials not properly secured, aisle ways blocked, and damage to the rack system such as broken or mangled rack legs, crushed cross braces, bent and broken shelving. The investigation revealed that collapsed or falling loads were a daily occurrence at the facility. None of these hazards were in the control of the contractor, but their employees were exposed daily to these hazards. Both the host and contract employers were cited as a result of the investigation.

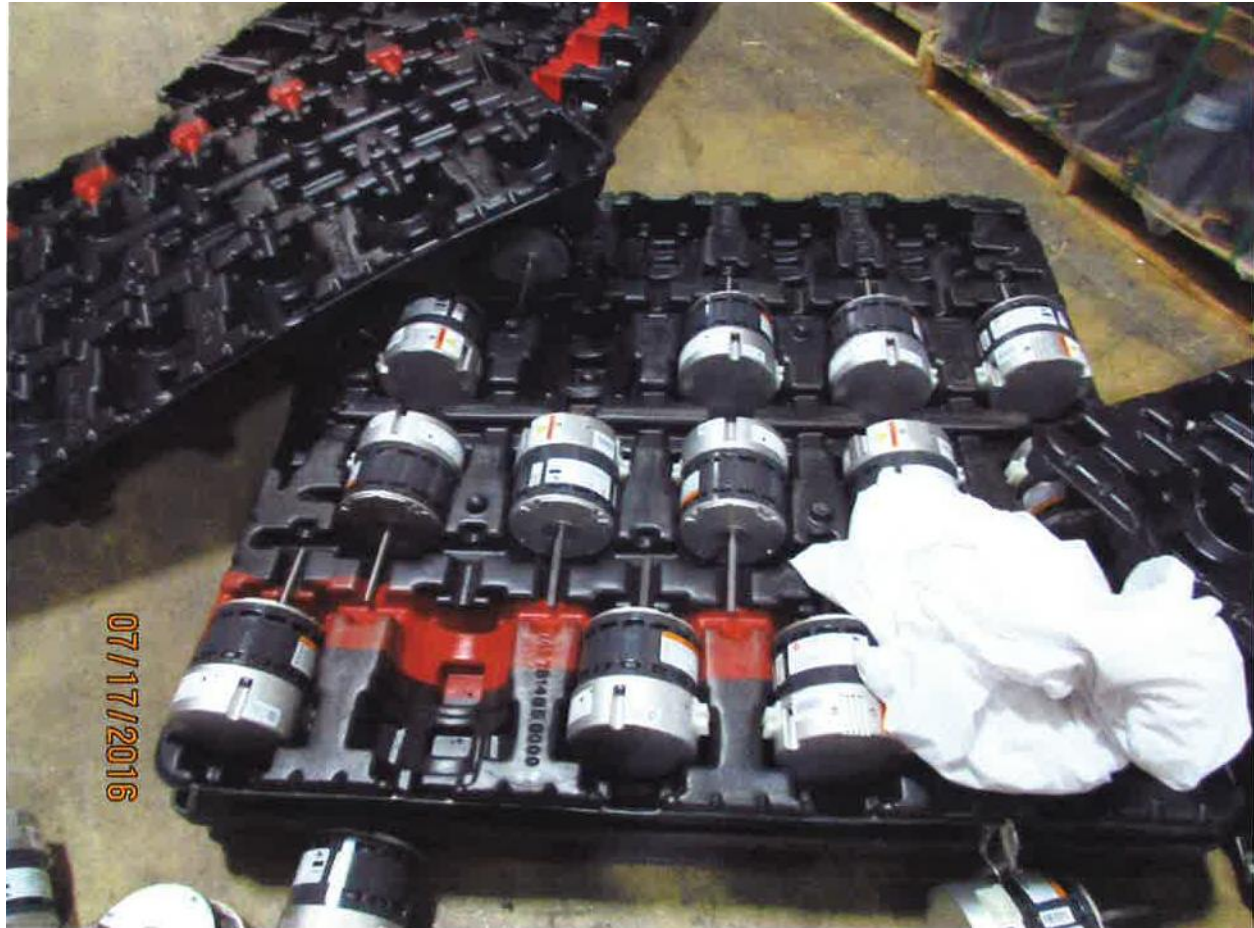
Photo 1 of 1 – Trays partially filled with approximately 12 of the 140 residential HVAC motors that were packaged on the skid that fell over striking the victim.

29 CFR 1910.176(b)	Material stored in tiers was not stacked, blocked, interlocked or limited in height so that it was stable and secure against sliding and collapse. In that material located in the vender warehouse was not secured and prevented from sliding or collapse while in storage in the following instances: a) An employee from a contracted company was walking down a main aisle way used for access and egress to the contractor's work location when a second level stacked skid from the floor stack area containing 140 11-pound HVAC motors collapsed striking and killing the employee. b) Throughout the vender warehouse that is used by employees and contains an aisle way that is used by contract employees, the pallets of material were found to be fallen over, collapsed, and leaning onto other material on the rack systems. These areas are used daily by employees and are constantly being restacked, stocked and product delivered to the production lines.
